**[Docket No. FAA-2012-0060; Directorate Identifier 2012-NE-02-AD; Amendment 39-17123; AD 2012-14-09]**

**Airworthiness Directives; Pratt & Whitney (P&W) Division Turbofan Engines**

**ACTION:** Final rule.

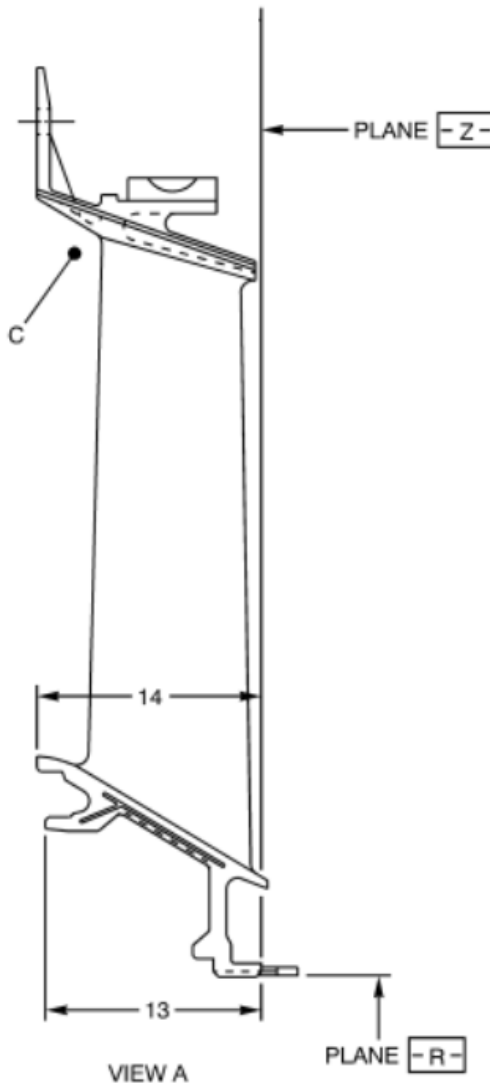
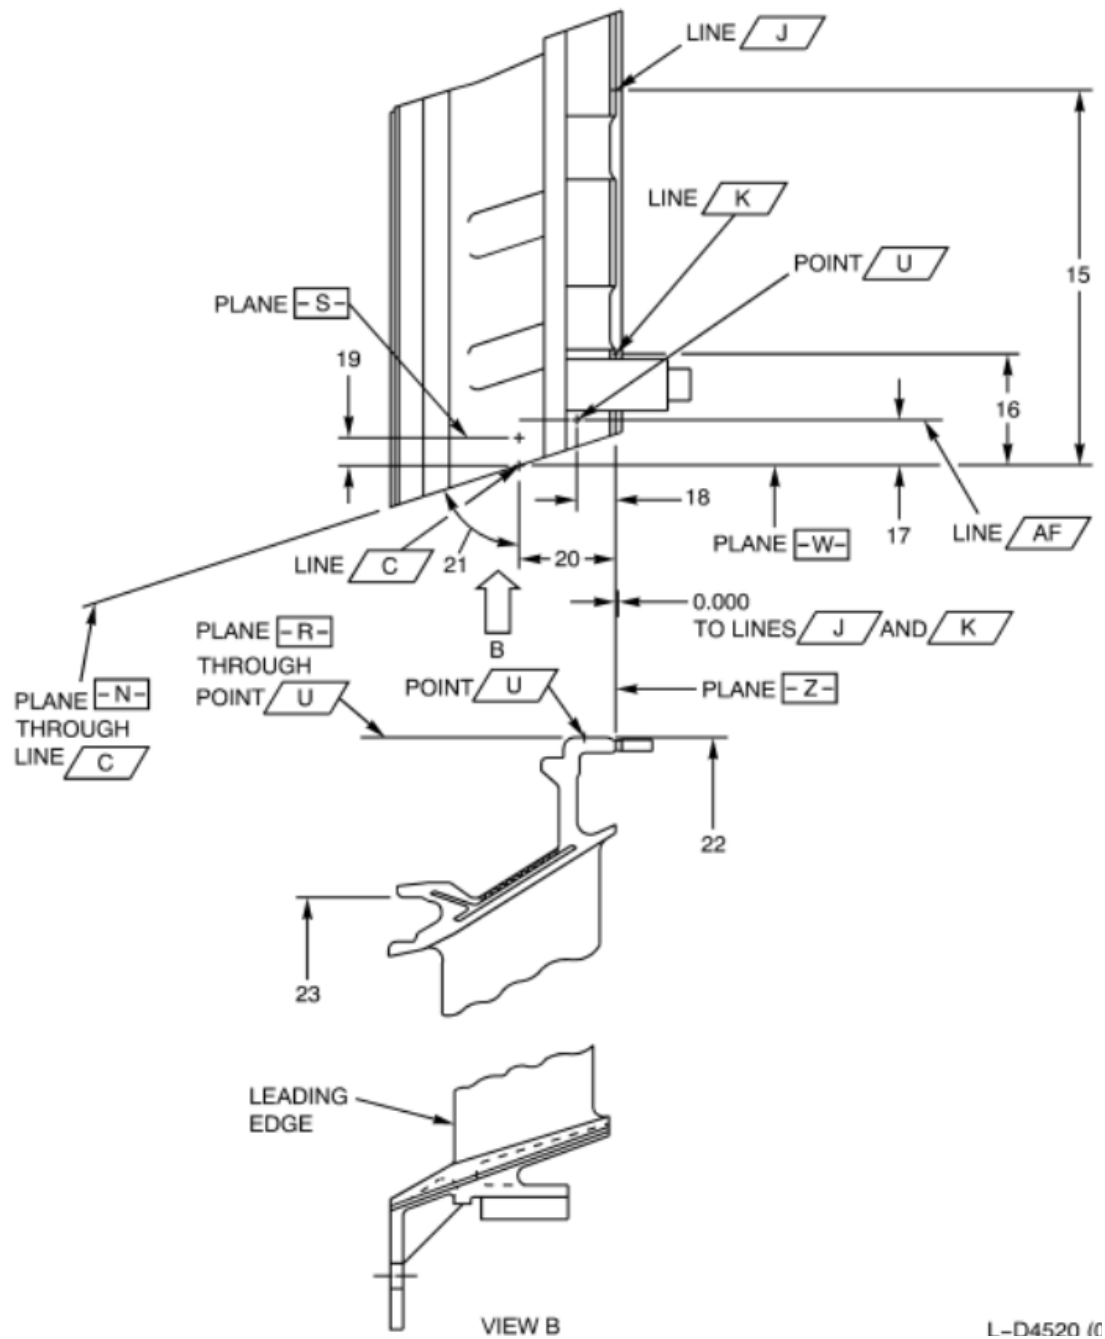
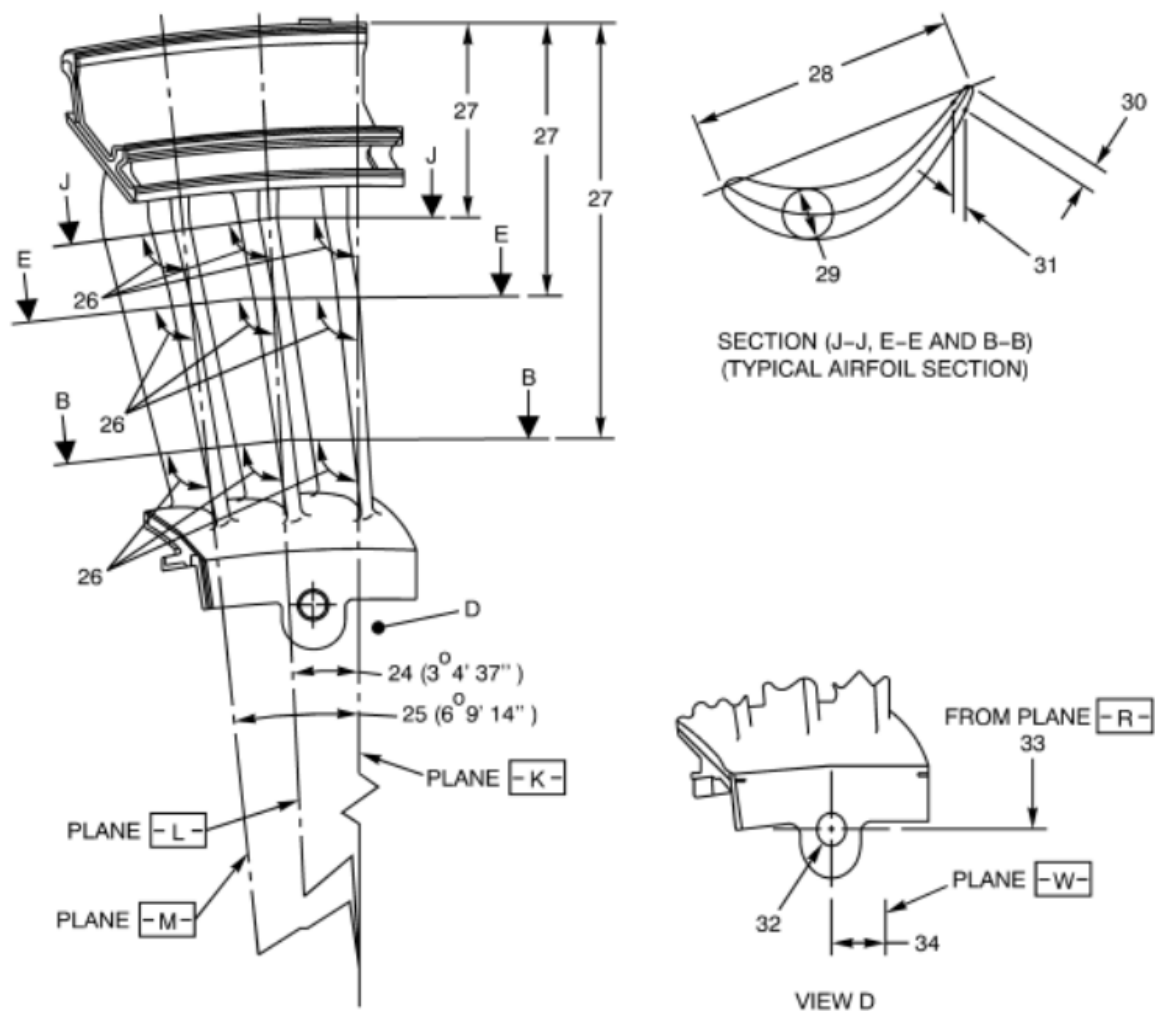
(iii) Dimensionally examine index 13 through index 34 of the LPT 3<sup>rd</sup> stage vane cluster assembly. Use Table 2 to paragraph (e) of this AD and Figure 1, Figure 2, and

Figure 3 to paragraph (e) of this AD to determine whether the vane is eligible for installation.

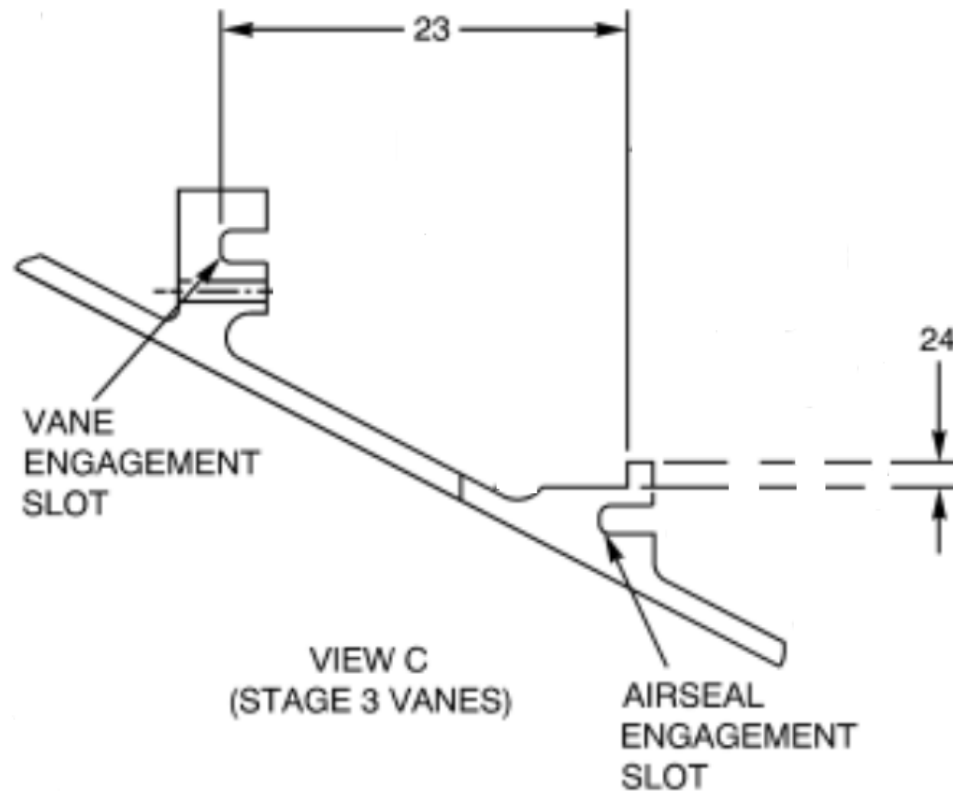
**Figure 4 to Paragraph (e) - Determination of Case Eligibility**

(iv) Dimensionally examine index 23 and index 24 of the vane engagement slots on the rear turbine case, where the 3<sup>rd</sup> stage vane is installed. Use Table 3 to paragraph (e) of this AD and Figure 4 to paragraph (e) of this AD to determine whether the case is eligible for installation.
